# Manhole Inspection Summary

Manhole # S29M\_\_048MH

Insp Date: **12/15/08 10:06 AM**

**Location** Address: **773 Carroll St**

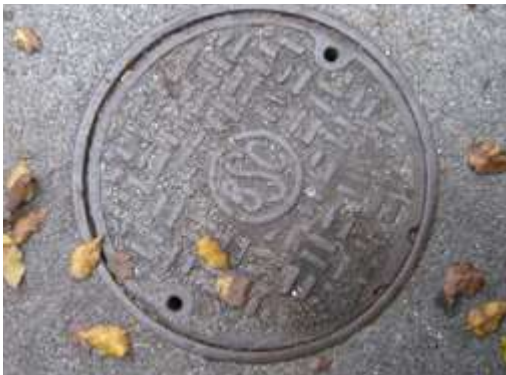
cover pic

Condition: **Sound**

Condition: ☐ Sound ☐ Cracked ☒ **Leaks**

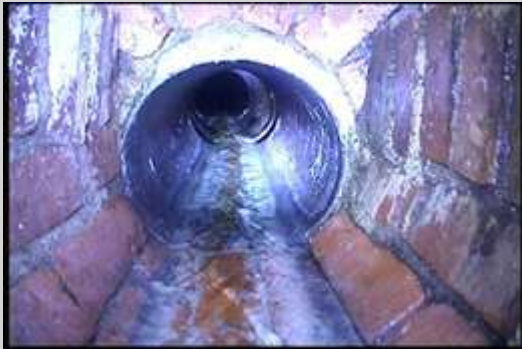
12 O'Clock Outflow

Pipe Height: **8.4** (in.) Rod and Bar (Angled)  
Pipe Material: **Clay** ☐ Pipe Lined  
Invert Depth: **9.82** (ft.) Flow Characteristics: **Fast**  
Deposits: ☒ None ☐ Mud ☐ Sludge ☐ Debris ☐ Grease  
Silt Depth: **0** (in.) Deposits Extent:  
Infiltration: **None** Pipe Seal Cond: **Sound**

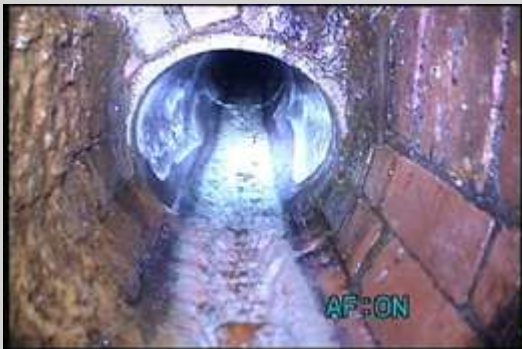
6 O'Clock Inflow

Pipe Height: **8.4** (in.) Rod and Bar (Angled)  
Pipe Material: **Clay** ☐ Pipe Lined  
Invert Depth: **9.88** (ft.) Flow Characteristics: **Fast**  
Deposits: ☒ None ☐ Mud ☐ Sludge ☐ Debris ☐ Grease  
Silt Depth: **0** (in.) Deposits Extent:  
Infiltration: **None** Pipe Seal Cond: **Sound**

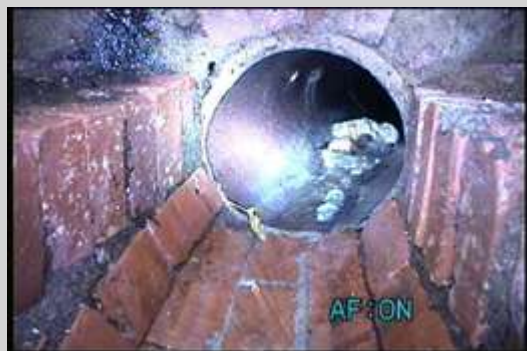
9 O'Clock Inflow

Infiltration: **None** Pipe Seal Cond: **Sound**
